TWR-17371

Space Shuttle Development Motor No. 9 (DM-9) Final Test Report

September 1990

Thiokol CORPORATION
SPACE OPERATIONS

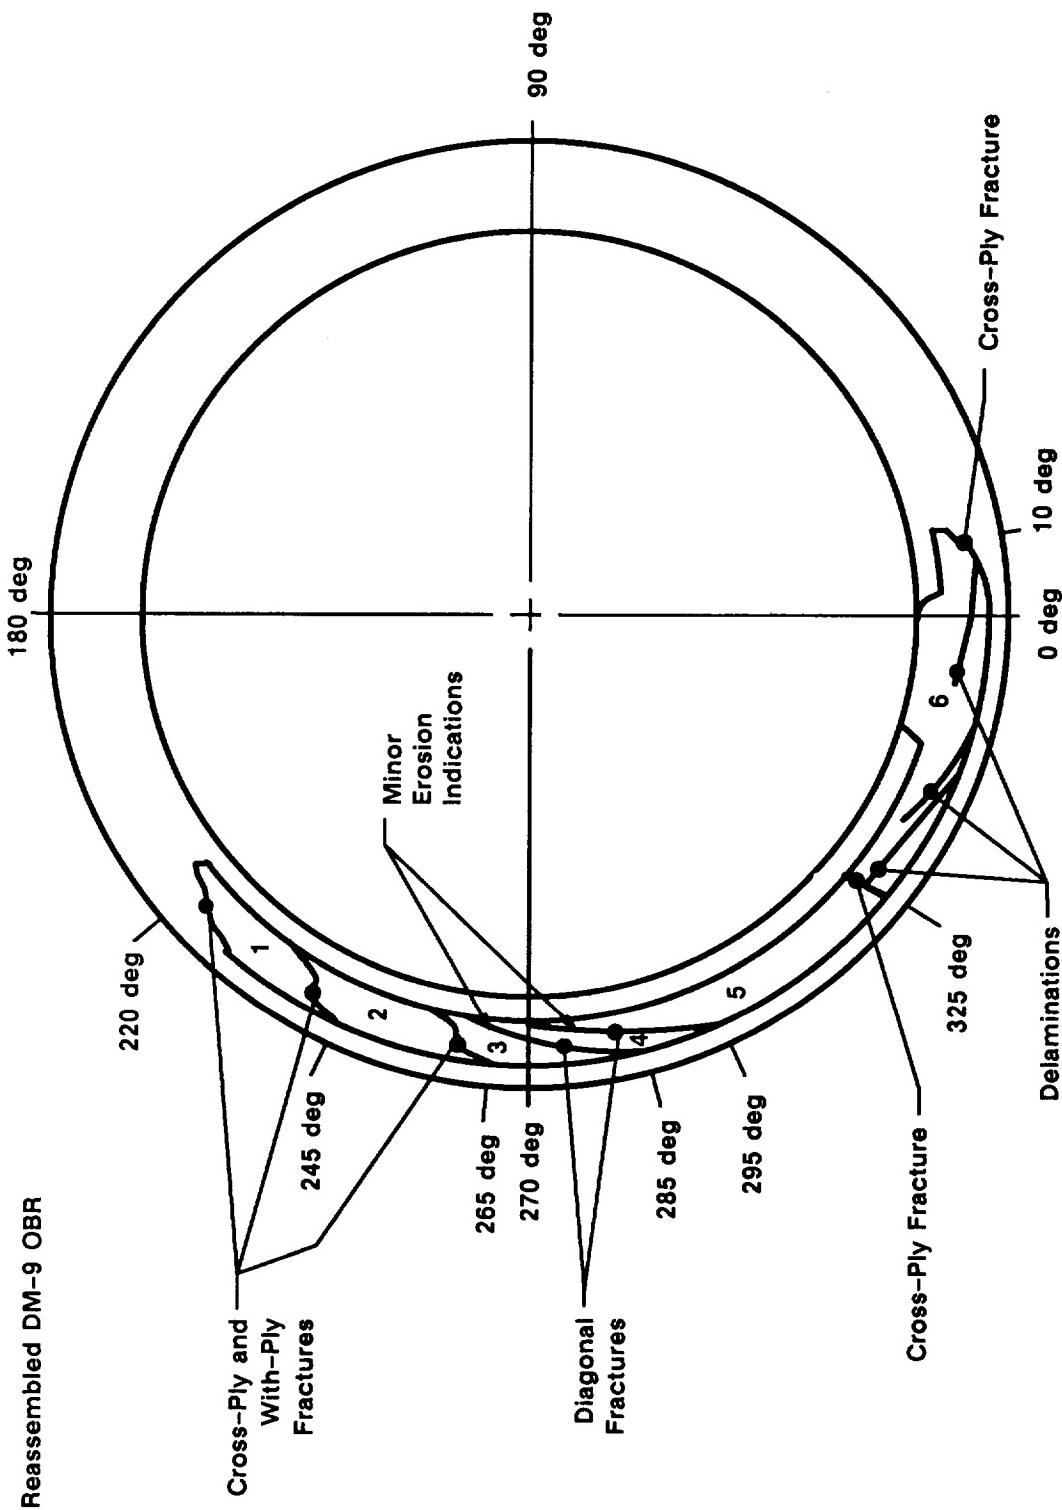
The six pieces of the OBR found on the floor of the aft segment were reassembled and examined (Figures 7.5-31 through 39). Figure 7.5-40 is a map of the reassembled pieces. Figure 7.5-41 describes the fracture edges and overall condition of Piece No. 1. Piece No. 2 is summarized in Figure 7.5-42. Figures 7.5-43 through 7.5-46 describe Piece No. 3, and Figures 7.5-47 through 7.5-50 characterize Piece No. 4. Piece No. 5 is described in Figure 7.5-51, and Figures 7.5-52 and 7.5-53 summarize Piece No. 6.

Figure 7.5-40. DM-9 Mapping of Reassembled Pieces of OBR

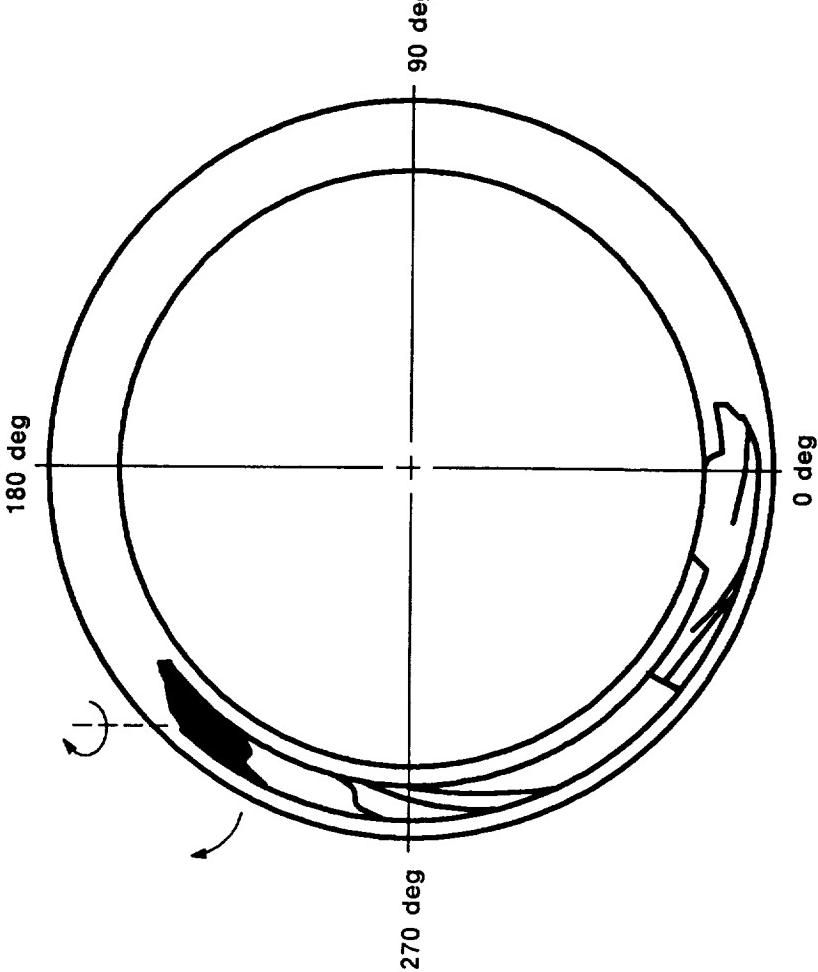
Figure 7.5-41. DM-9 OBR Piece No. 1 Description

- Piece No. 1—220 to 245 deg— was found buried in slag approximately 8.0 ft forward of the nozzle nose cap
- Sectioning revealed that Piece No. 1 was completely charred through
- The 220-deg and 245-deg fractured ends of Piece No. 1 showed signs of both cross-ply and with-ply failure
- The 220-deg fractured end contained indications of bending/torsion fracture
- The 245-deg fractured end contained indications of bending fracture
- Erosion was not present on fractured or ID surfaces

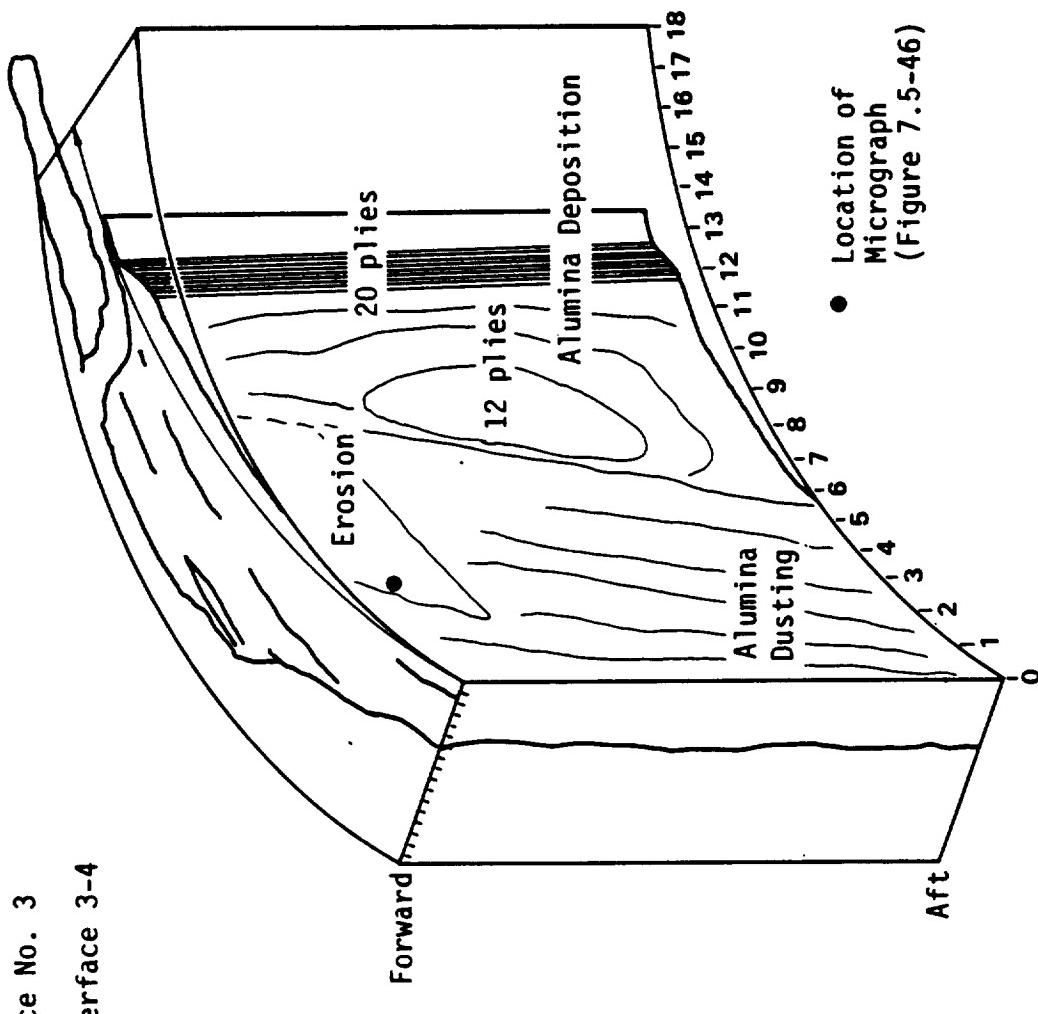
- Piece No. 3 —265 to 285 deg—was found lying on top of the slag under the nozzle nose cap
 - Sectioning revealed that Piece No. 3 was completely charred through
 - The 265-deg fractured end of Piece No. 3 showed signs of both cross-ply and with-ply failure
 - The 265-deg fractured end contained indications of bending fracture
 - The 285-deg fractured end of Piece No. 3 failed with-ply, with localized cross-ply fracture
 - The 285-deg fractured end contained indications of delamination with mechanical load assist
 - Erosion and flow indications were found near the ID surface along diagonal fracture (photo micrographs show rounding of the fibers – Figure 7.5-46)
-

Figure 7.5-44. DM-9 OBR Ring Piece No. 3 Description

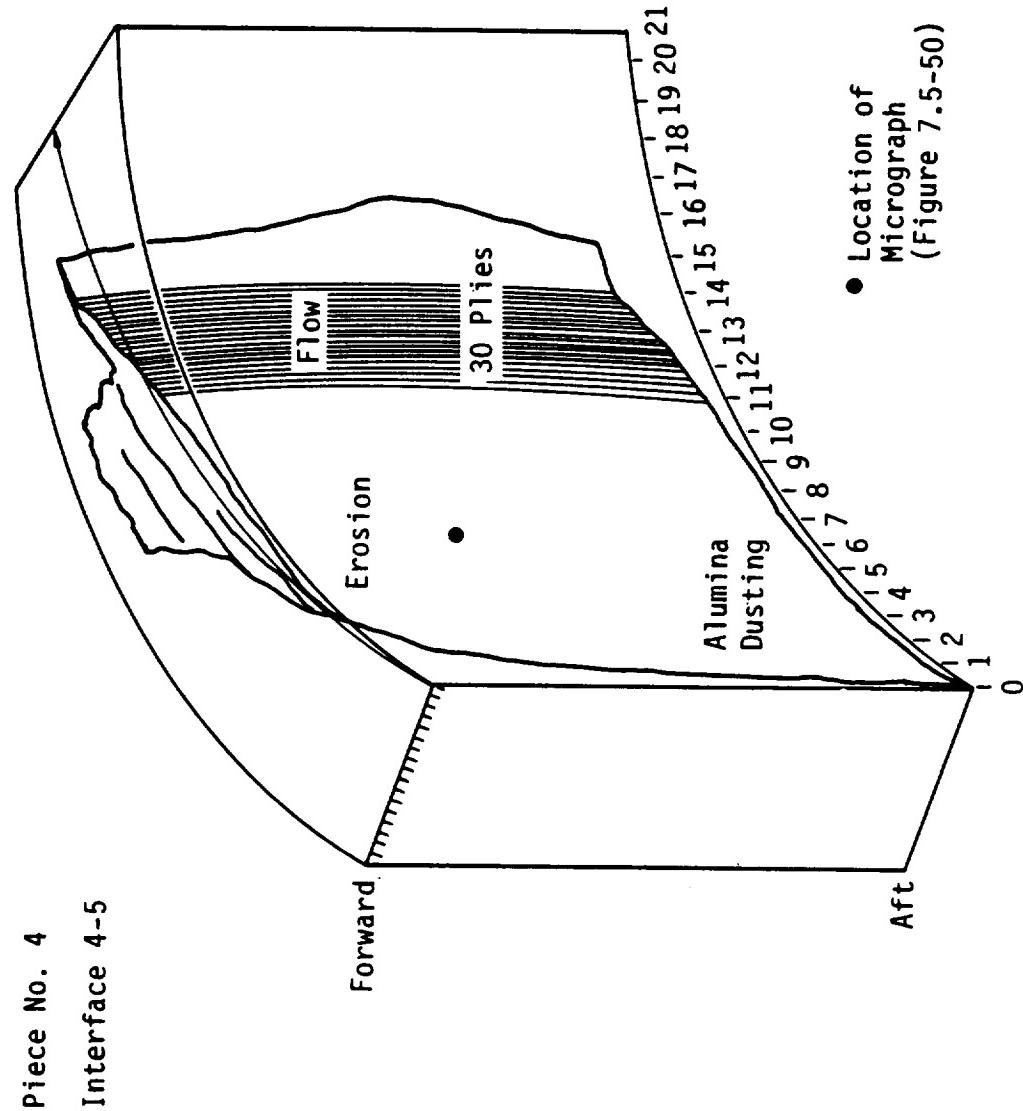
- Piece No. 4—285 to 295 deg—was found under the nozzle nose cap lying on top of the slag
- Sectioning revealed that Piece No. 4 was completely charred through
- The 285-deg and 295-deg fractured ends of Piece No. 4 failed with-ply, with localized cross-ply fracture
- The 285-deg and 295-deg fractured ends contained indications of delamination with mechanical load assist
- Erosion and flow indications were found near the ID surface along through-delamination (photo micrographs show rounding of the fibers—Figure 7.5-50)

Figure 7.5-48. DM-9 OBR Ring Piece No. 4 Description

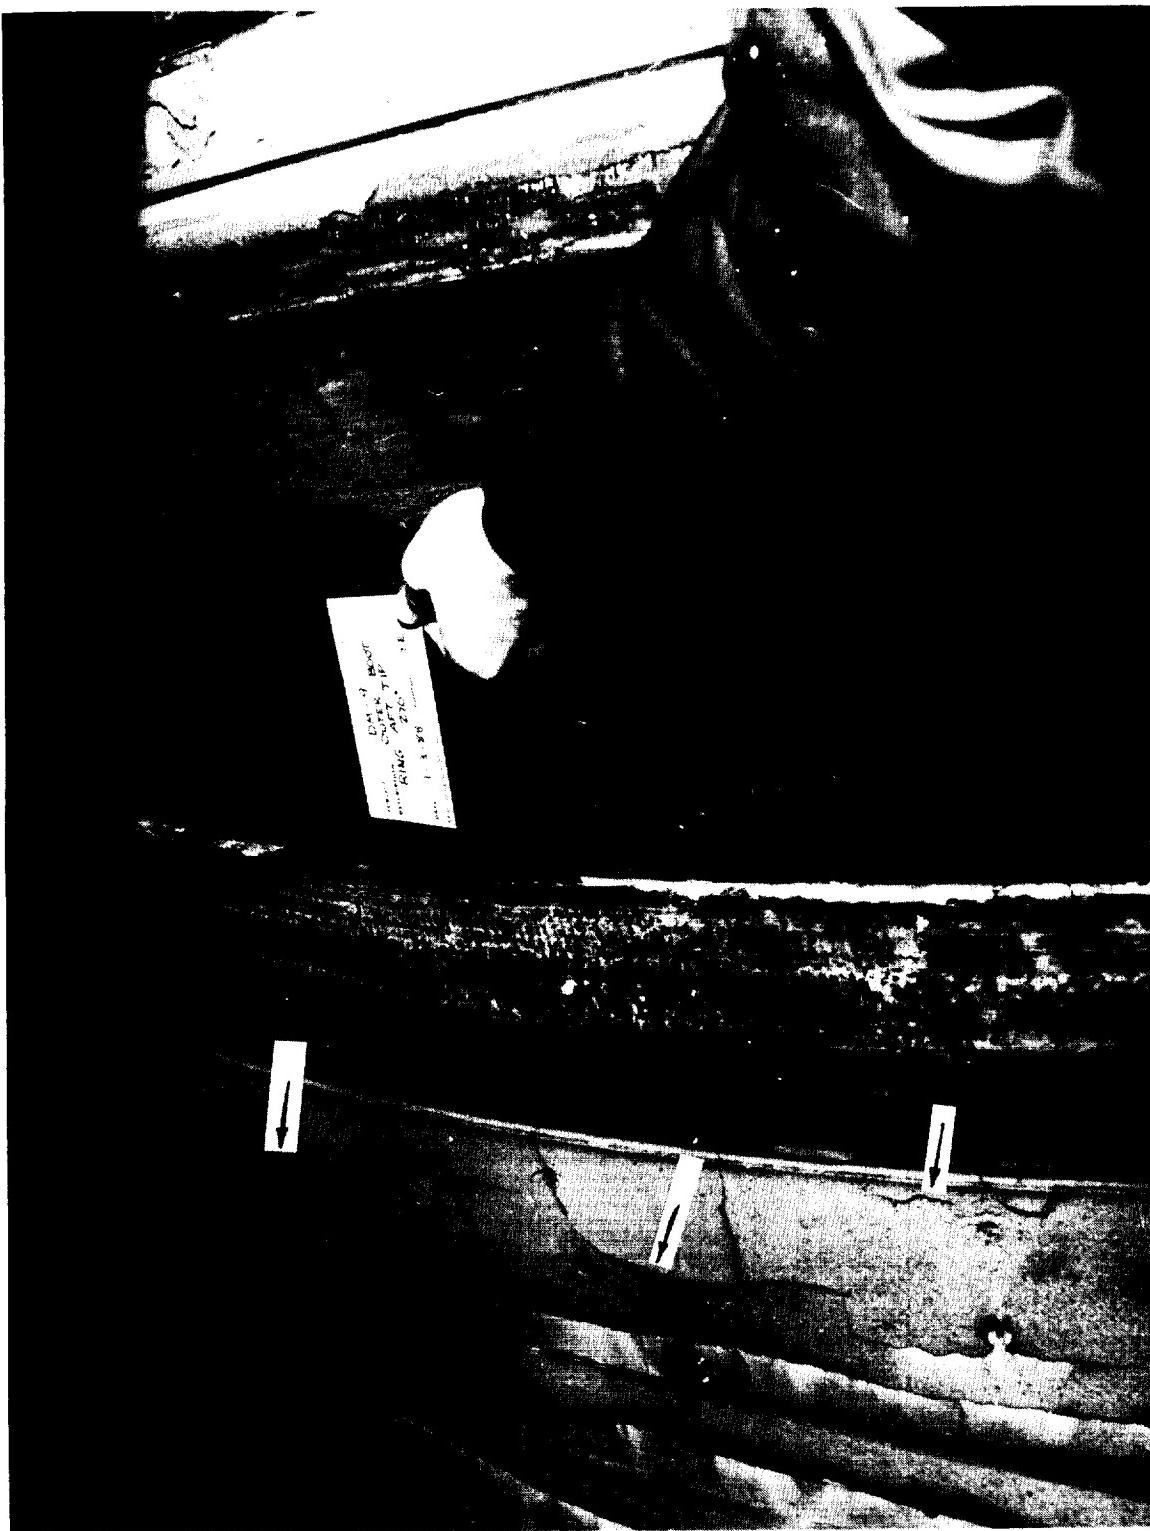
The DM-9 cowl ring showed irregular erosion patterns intermittently around the part circumference (Figures 7.5-54 and 7.5-55). The forward portion of the cowl ring appeared to erode approximately 0.20 in. more than the aft portion of the ring in the areas of the irregular erosion. This type of erosion was observed on the DM-8 cowl ring. Previous flight and static test cowl rings have also shown minor washing patterns.

Figure 7.5-54. DM-9 Cowl Ring Irregular Erosion Patterns (270 deg)

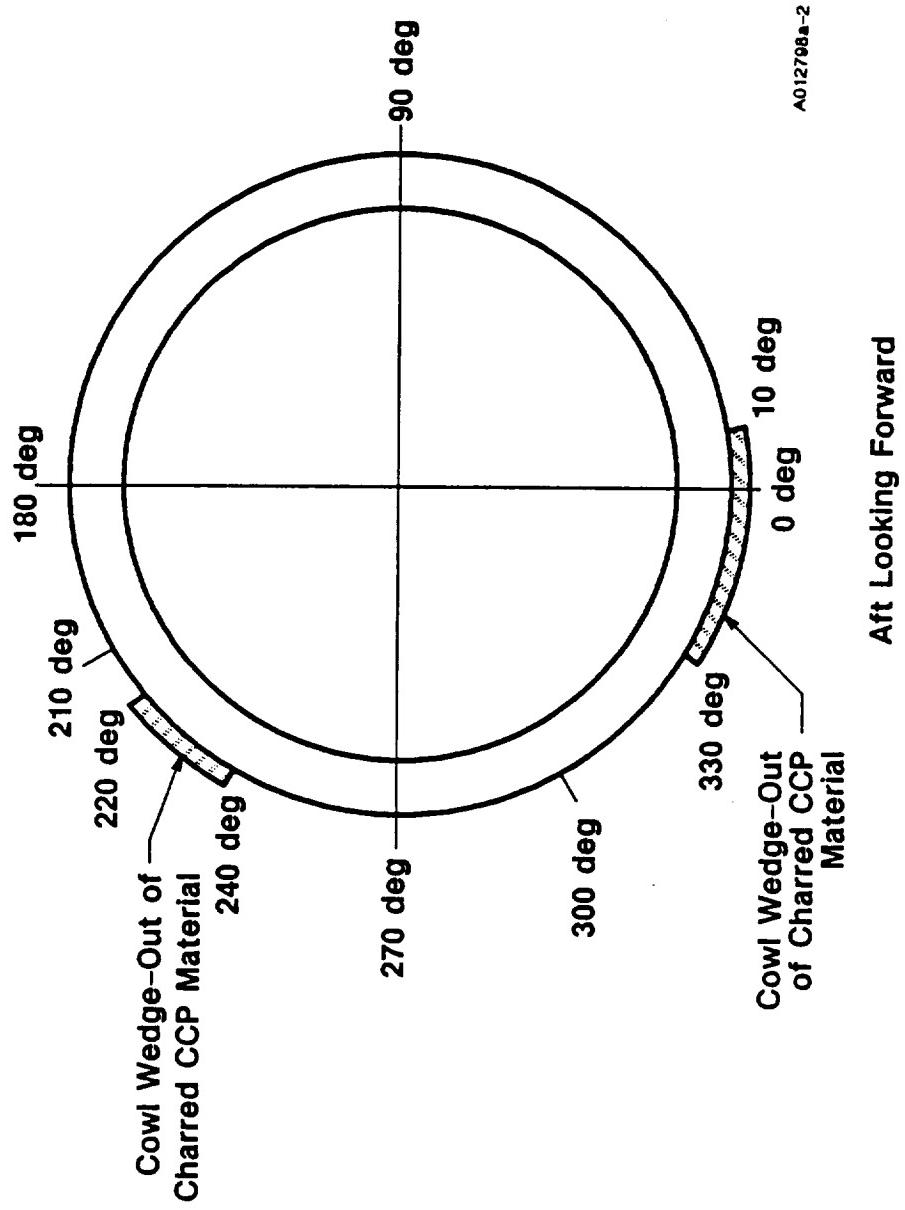
Figure 7.5-56. DM-9 Cowl Ring Wedge Out Locations

- The cowl ring showed wedge-out of charred CCP material from 220 to 240 deg and from 335 to 10 deg

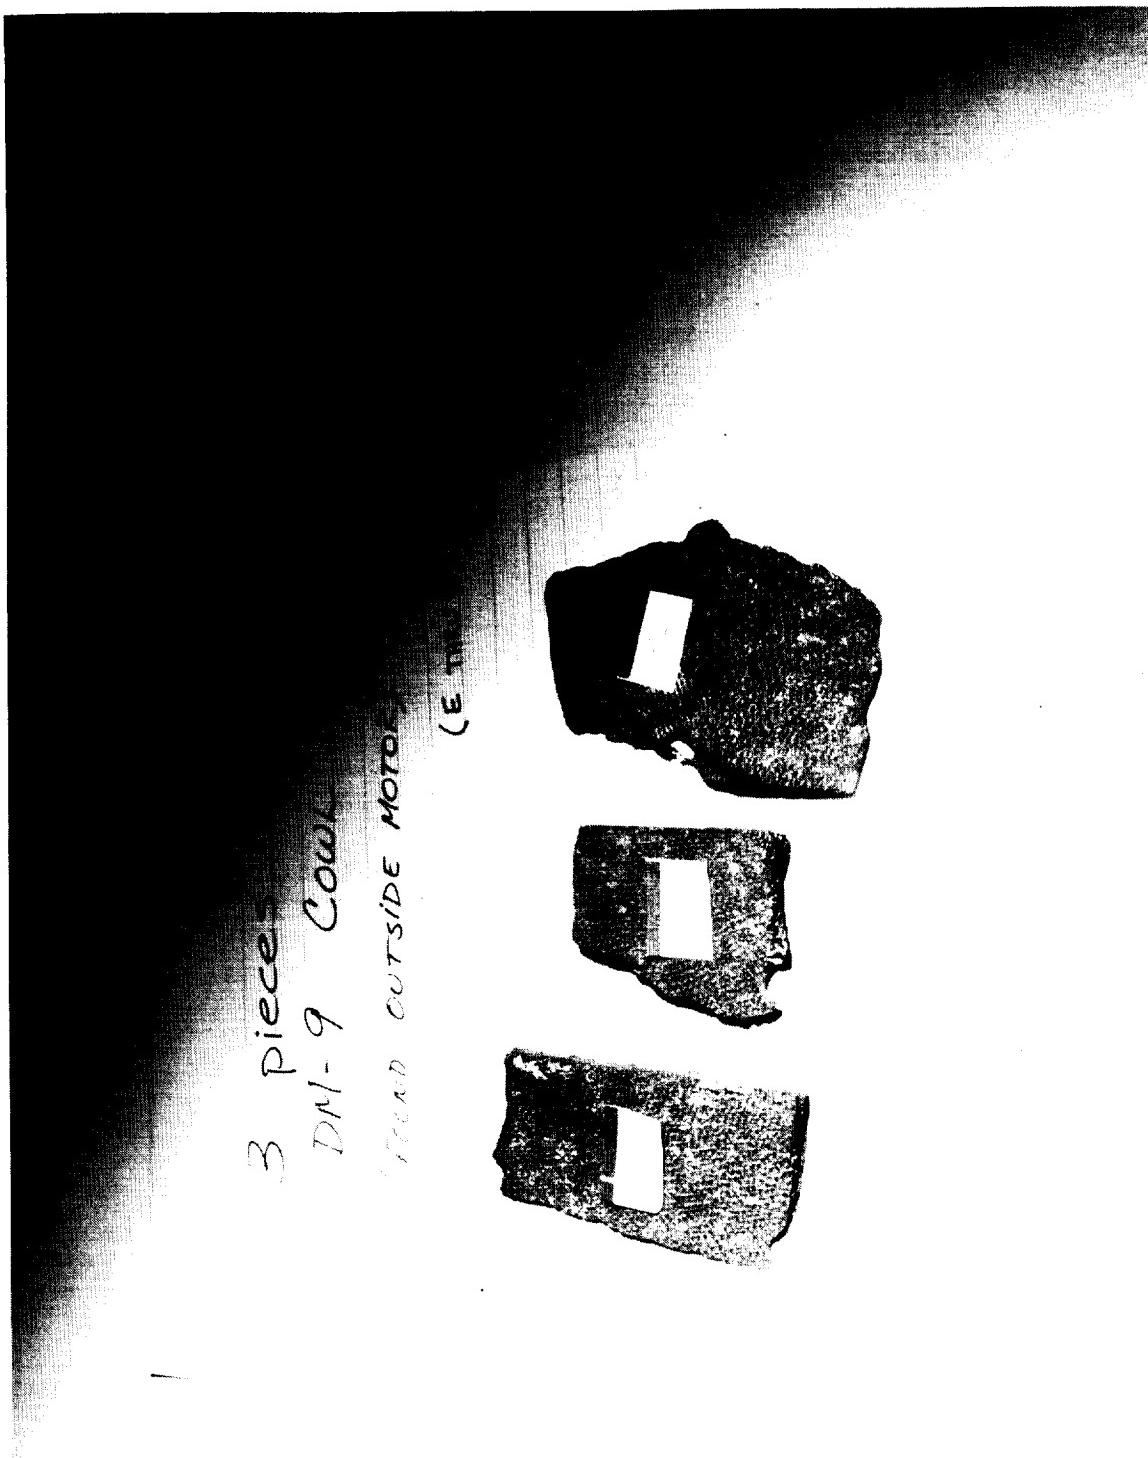
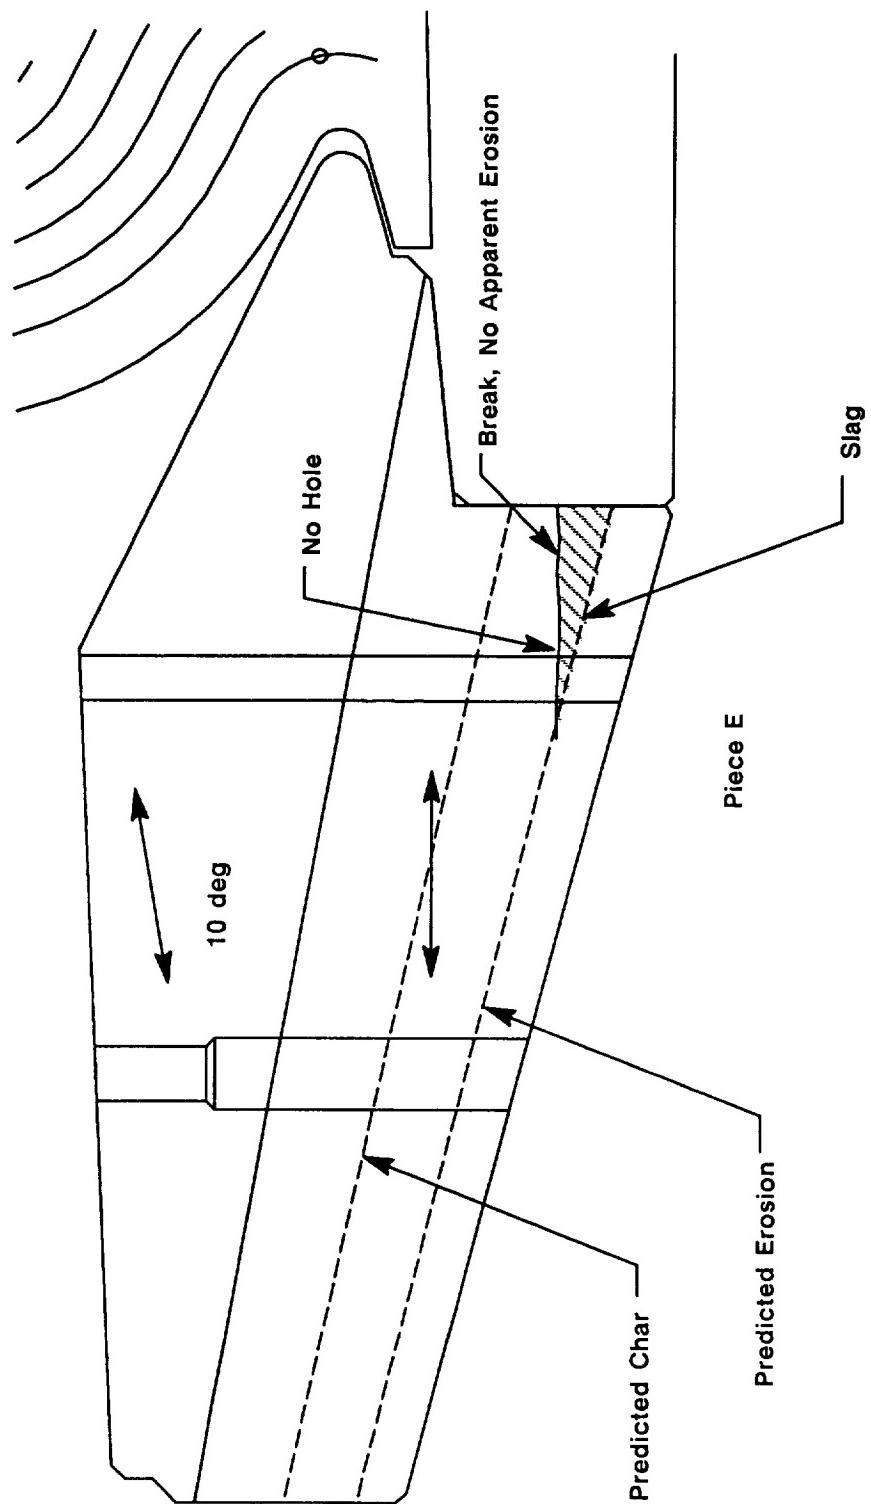
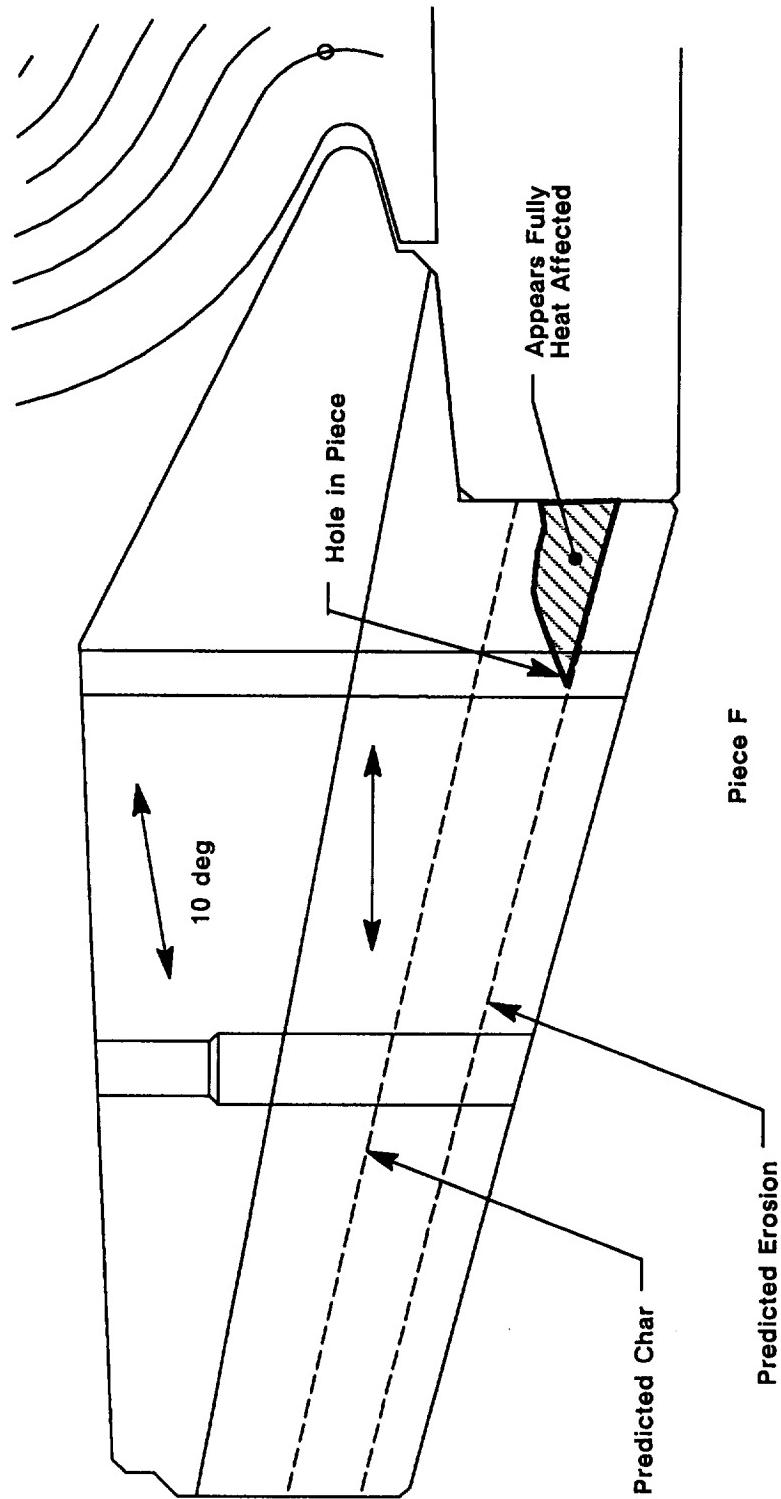
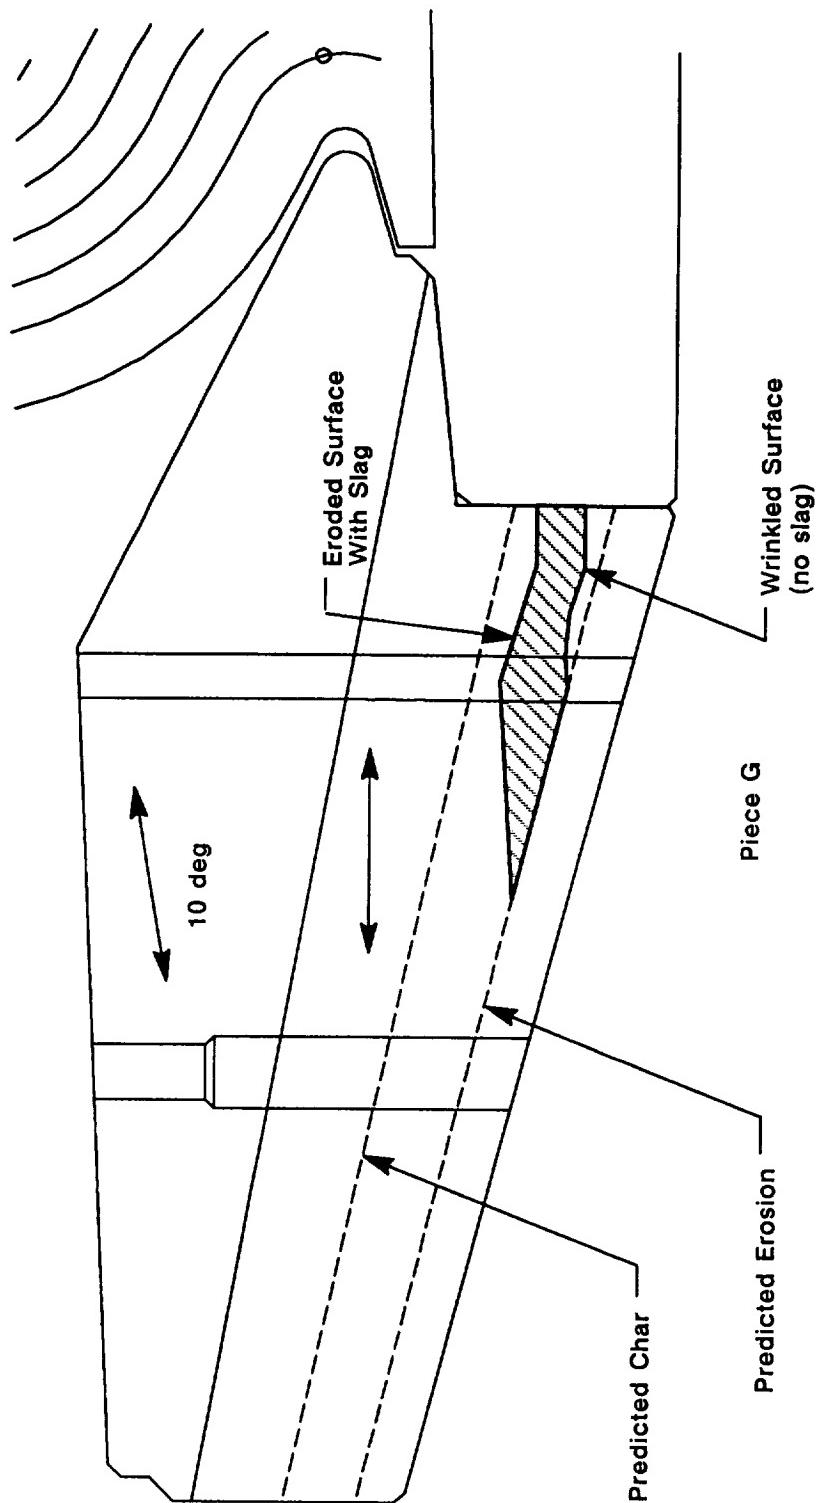
Charred CCP material wedged out on the aft 3.0 in. of the cowl ring from 220 to 240 deg and from 335 to 10 deg (Figures 7.5-9, 7.5-11 and 7.5-56). Three pieces of the wedged out CCP were found downstream of the motor (Figures 7.5-57 through 7.5-60). One of the pieces showed erosion and slag on the fracture surface. Sectioning of the cowl ring revealed that the char line was only slightly affected in the areas of the wedge outs. This indicates the material wedged out late in motor operation. The char line indicates that the 220- to 240-deg wedge out occurred earlier than the 335- to 10-deg wedge out.

Figure 7.5-57. DM-9 Cow Ring Pieces Found Outside of Motor

Figure 7.5-58. Cowl Piece E Found Outside of DM-9 Motor

Figure 7.5-59. Cowl Piece F Found Outside of DM-9 Motor

Figure 7.5-60. Cowl Piece G Found Outside of DM-9 Motor

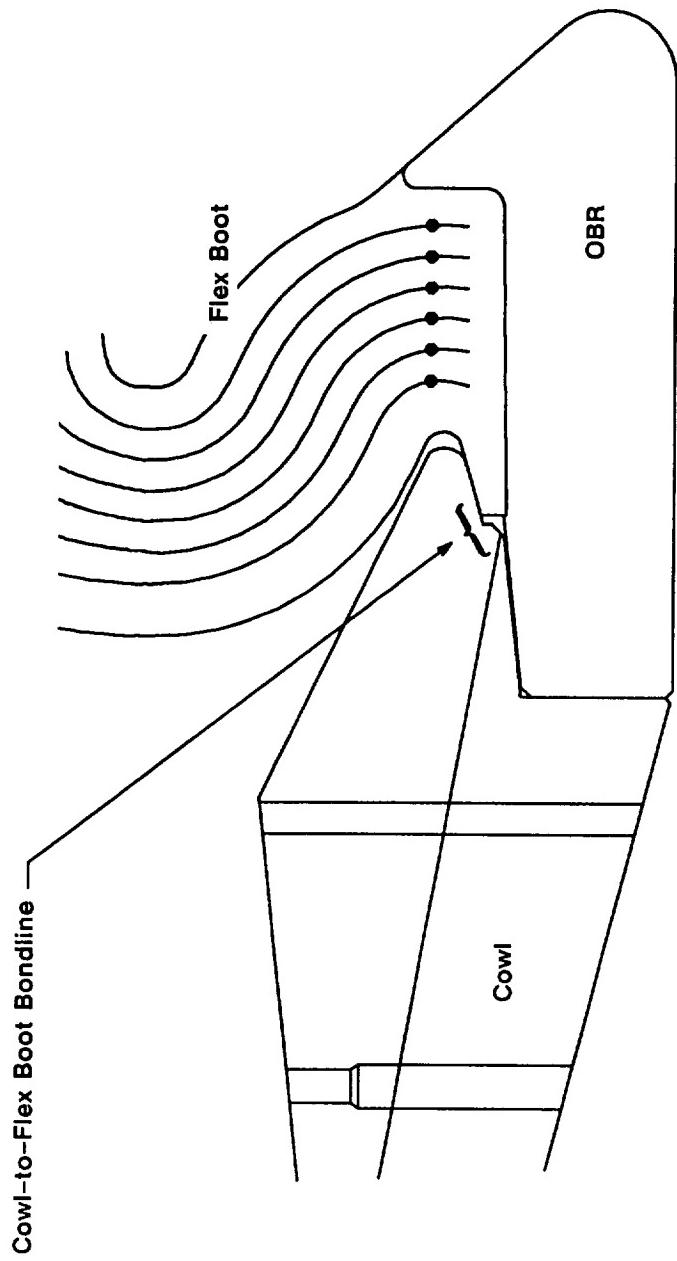
The cowl aft tip remained bonded to the flex boot around most of the circumference (Figure 7.5-62). Separations occurred between 240 and 300 deg. From 240 to 260 deg, approximately 60 percent of the bondline between the cowl and flex boot showed NBR remaining on the cowl aft tip. The bondline showed a 40-percent adhesive failure between the EA 913 adhesive and cowl aft tip. The separation from 240 to 260 deg resulted from a break within the flex boot and a partial adhesion degradation between the adhesive and cowl aft tip. From 260 to 300 deg, 100 percent of the bondline between the cowl and flex boot showed NBR remaining on the cowl

Figure 7.5-62. Cowl-to-Flex Boot Bondline Location

aft tip. The separation from 260 to 300 deg resulted from a break within the flex boot.

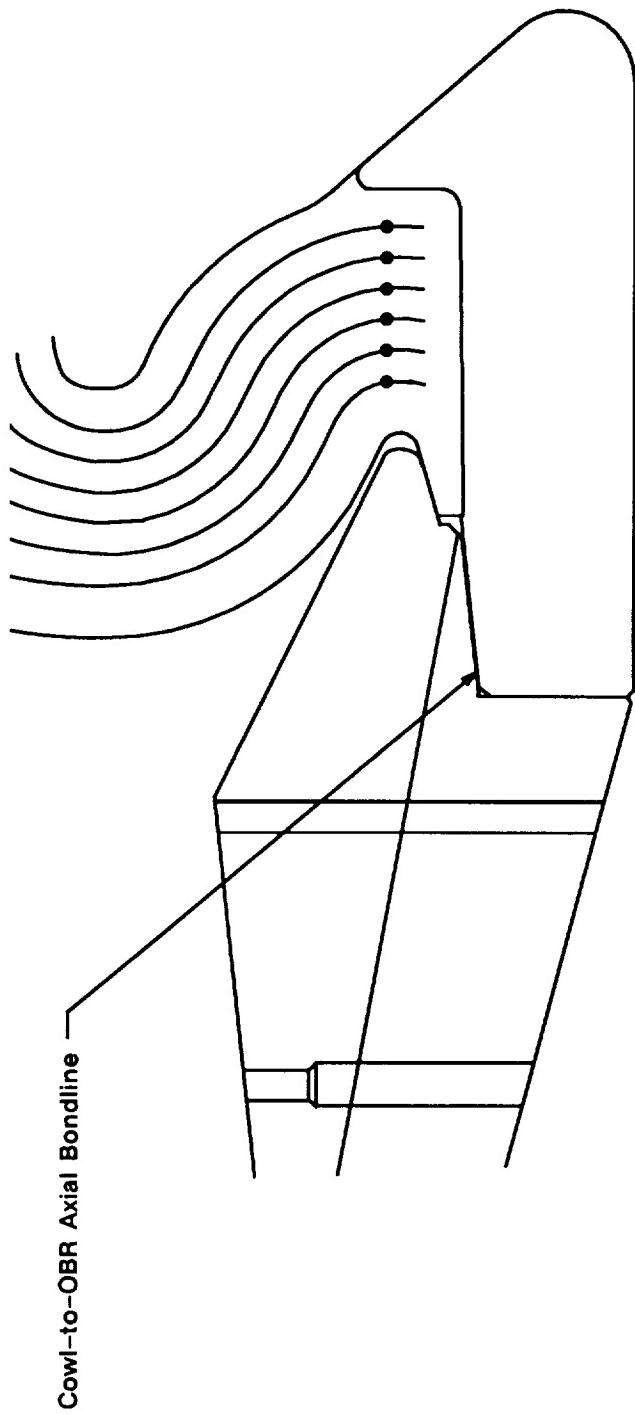
The axial bondline between the cowl ring and OBR (Figure 7.5-63) remained intact between 0 and 200 deg. Adhesive and cohesive failures were observed over the remainder of the bondline. From 200 to 360 deg, OBR CCP plies were observed bonded to the cowl primarily towards the forward end of the axial bondline (Figure 7.5-64). Adhesive failure between the EA 913 adhesive and cowl occurred primarily over the aft portion of the axial bondline. Figure 7.5-65 presents a map showing percent of cohesive failure along the cowl/OBR axial bondline from 200 to 360 deg. Cohesive failure was defined, as were OBR plies remaining bonded to the cowl.

Figure 7.5-63. Cowl-to-OBR Axial Bondline Location

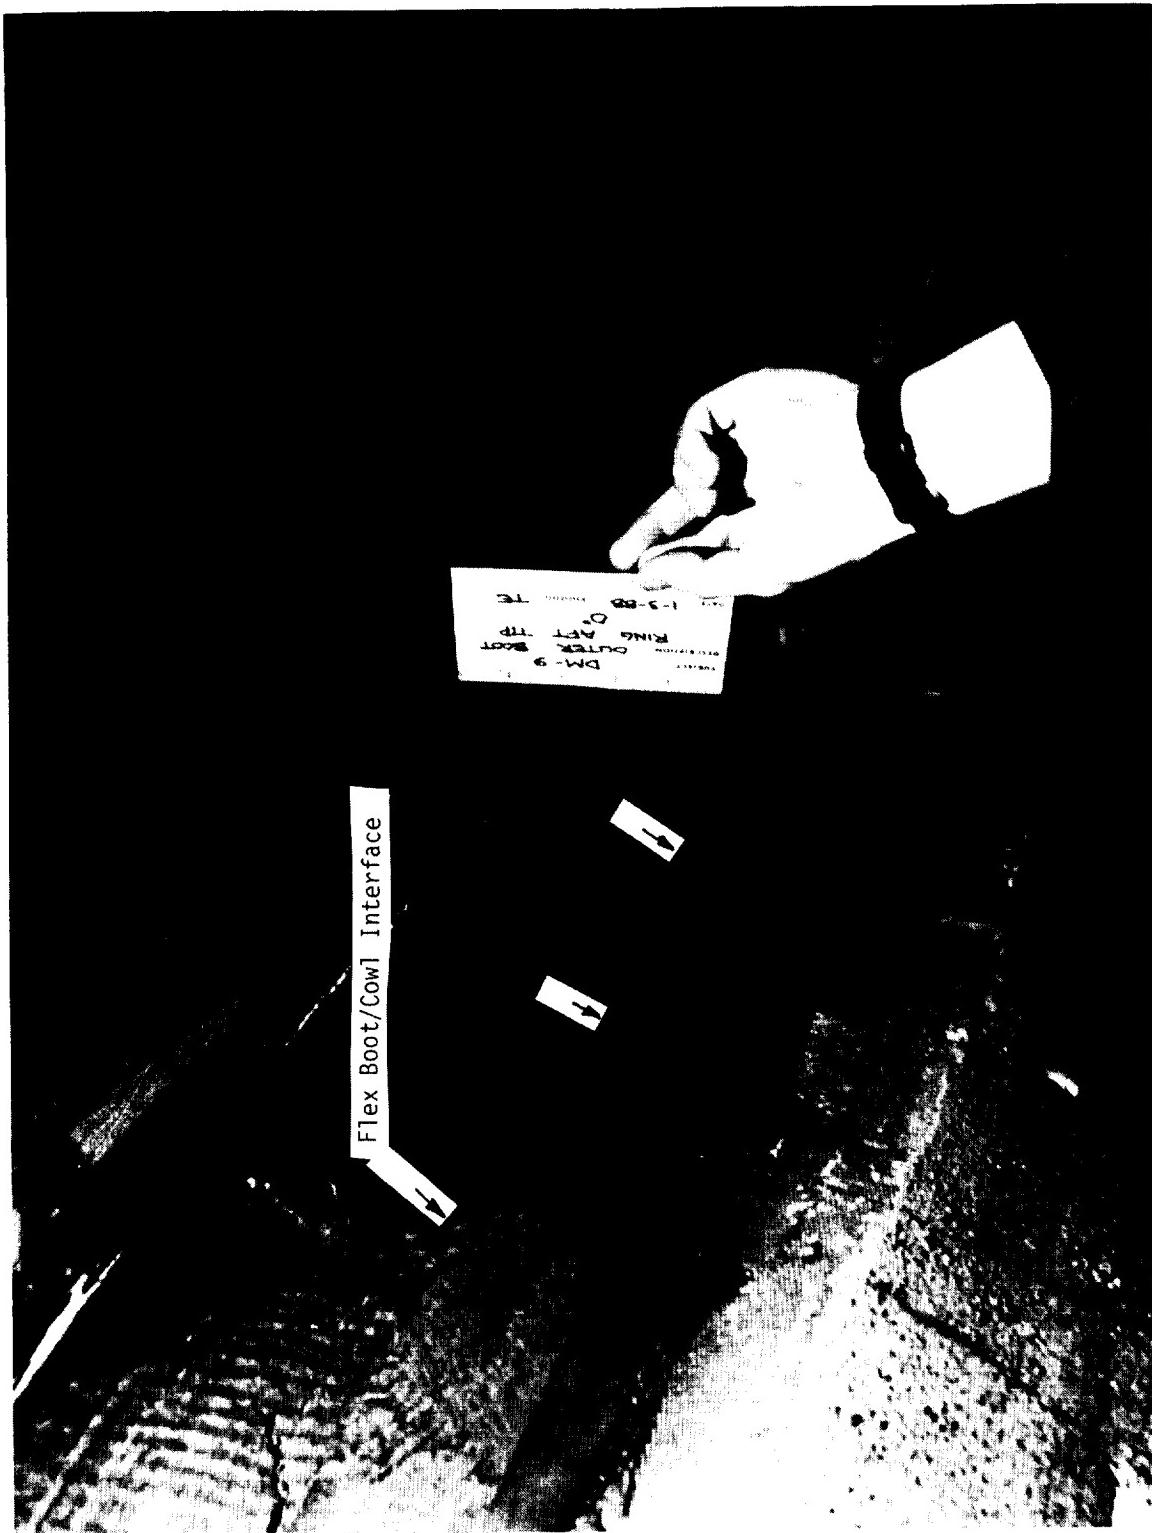
Figure 7.5-64. DM-9 Cow!/OBR Axial Bondline at 0 deg

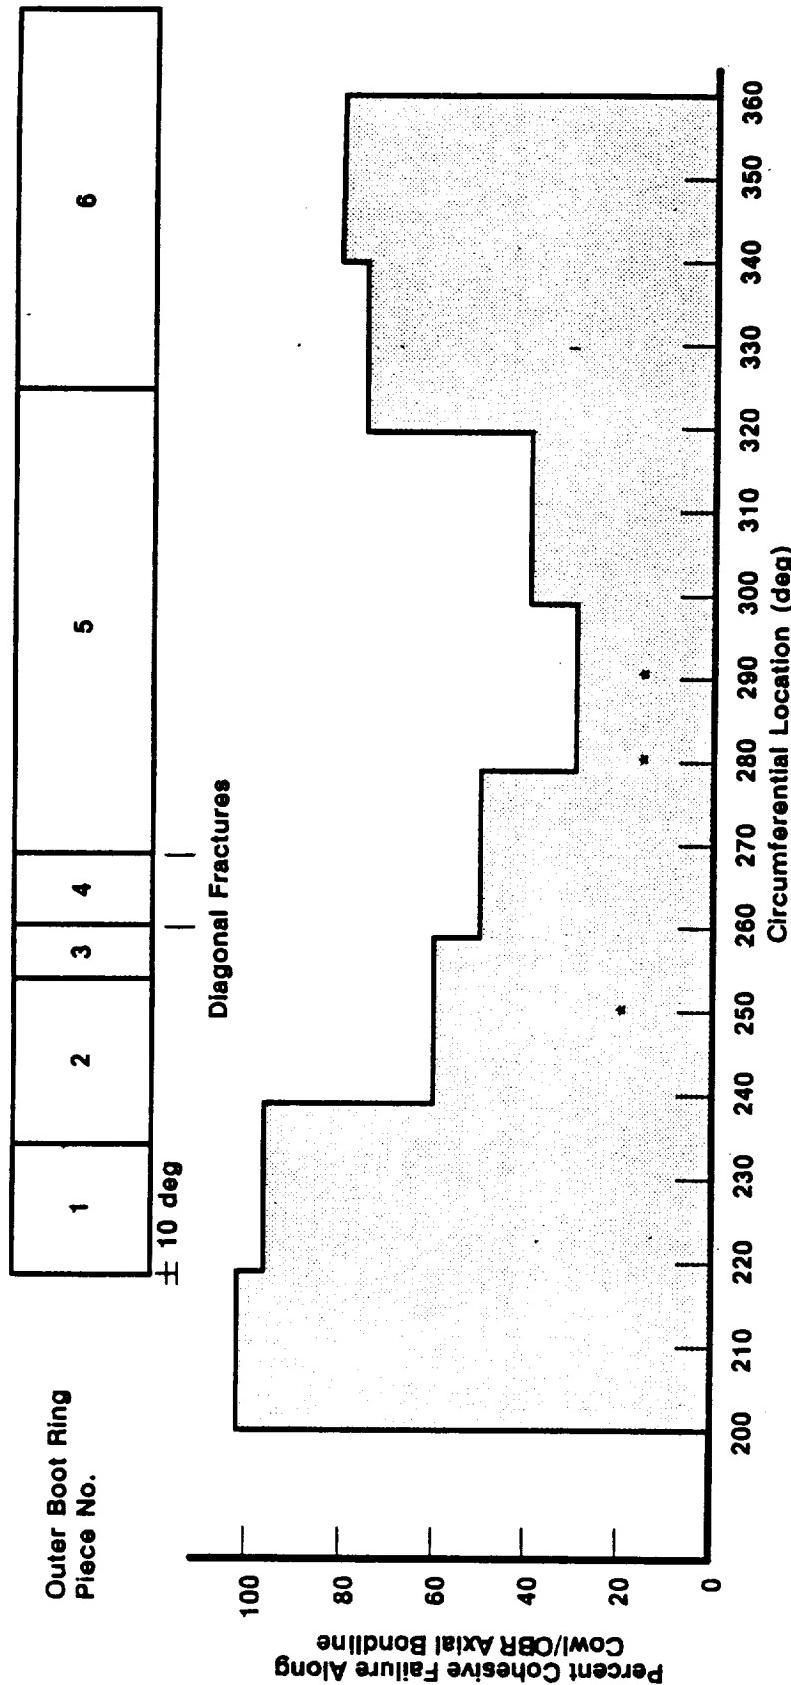
- Primary bondline failure mode was mechanical
- More plies from OBR remained on forward portion of axial bondline
- Thermal initiation possible at 250, 280 and 290 deg
- Extent of thermal degradation at time of bondline failure unknown

Figure 7.5-65. Percent Cohesive Failure Along Cowl/OBR Axial Bondline (200 to 360 deg)

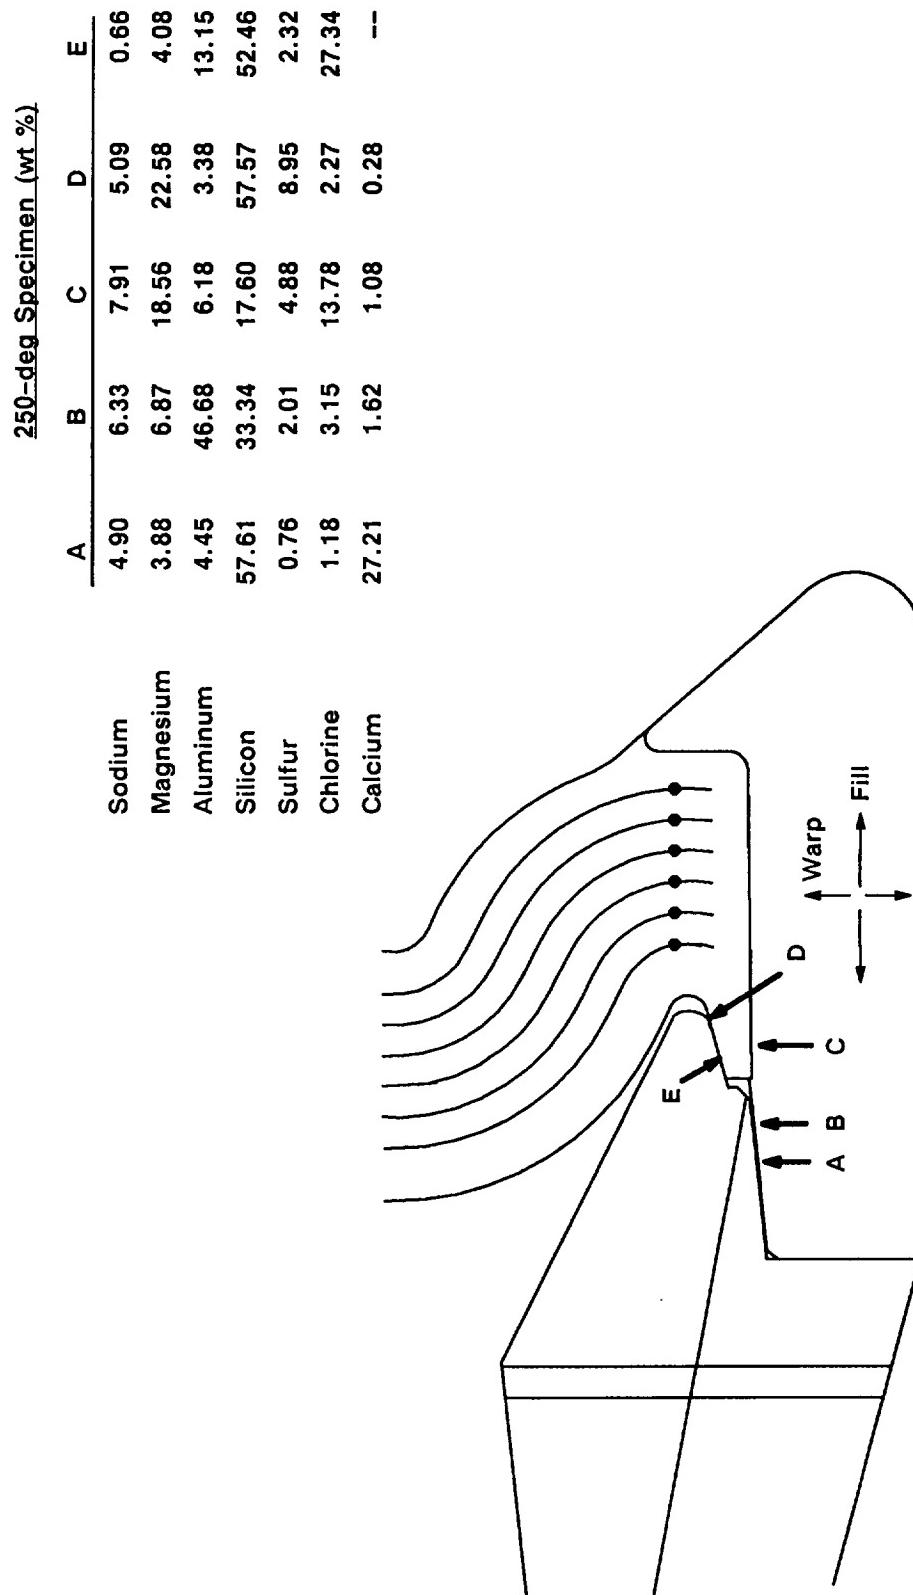
*Flow Indications From EDS (Figures 7.5-66 through 7.5-68)

Figure 7.5-66. DM-9 EDS Results at 250 deg

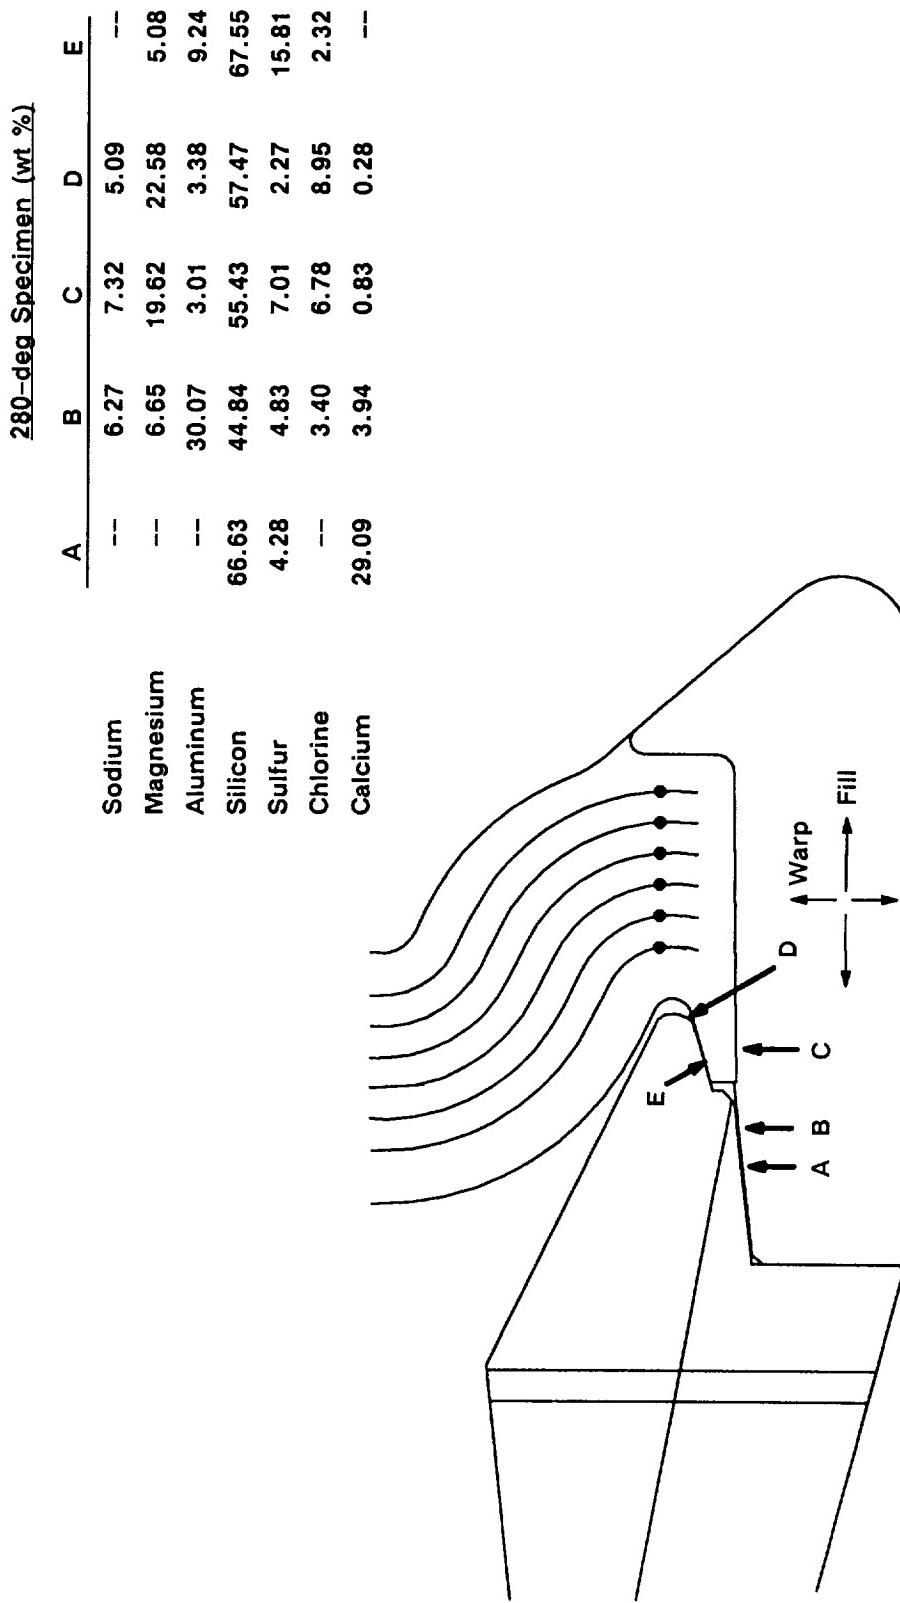
Figure 7.5-67. DM-9 EDS Results at 280 deg

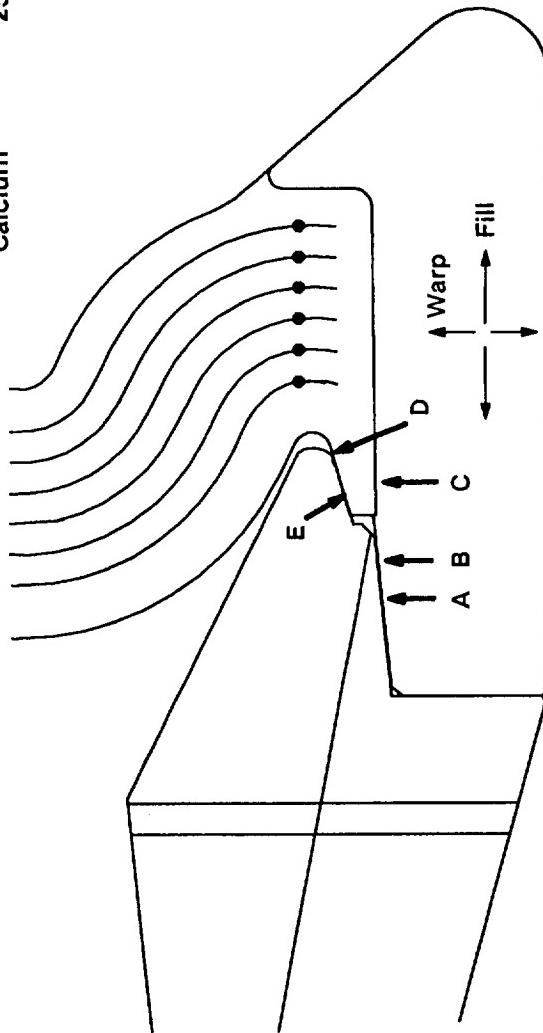
290-deg Specimen (wt %)				
	A	B	C	D	E
Sodium	3.86	--	7.61	5.09	2.18
Magnesium	3.11	--	20.16	22.58	2.82
Aluminum	4.58	34.88	3.94	3.38	13.46
Silicon	57.05	54.26	59.12	57.47	64.11
Sulfur	1.47	1.18	6.92	8.95	1.71
Chlorine	4.64	6.57	2.02	2.27	14.32
Calcium	25.30	3.11	0.24	0.28	1.40

Figure 7.5-68. DM-9 EDS Results at 290 deg
